# Lakemont Neighborhood Drainage Study

National Fish and Wildlife Foundation  
Chesapeake Bay Stewardship Fund,  
Grant #58834

March 1, 2019

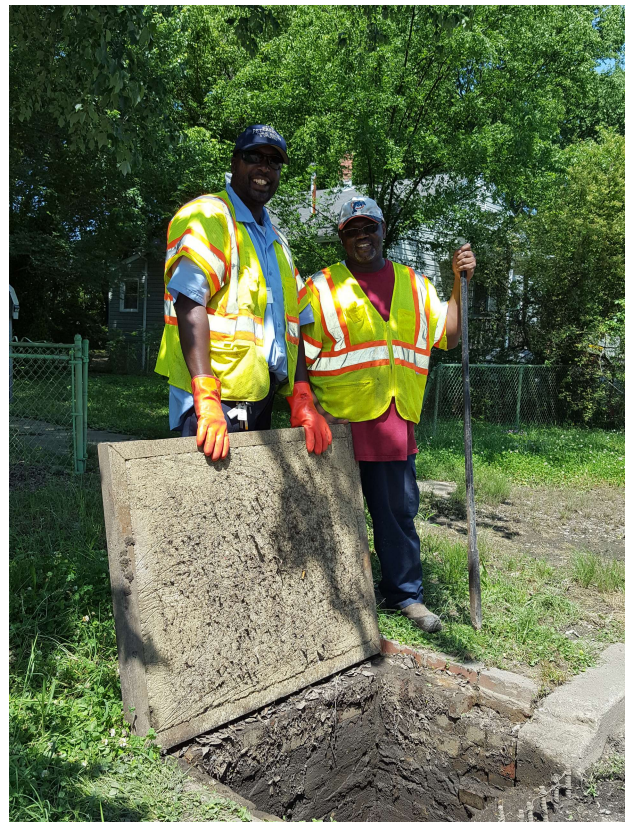
**Figure 7. City Streets Operations staff assisting with drainage investigations by jetting and vacuuming inlets and providing access to the drainage team on May 24, 2018.**

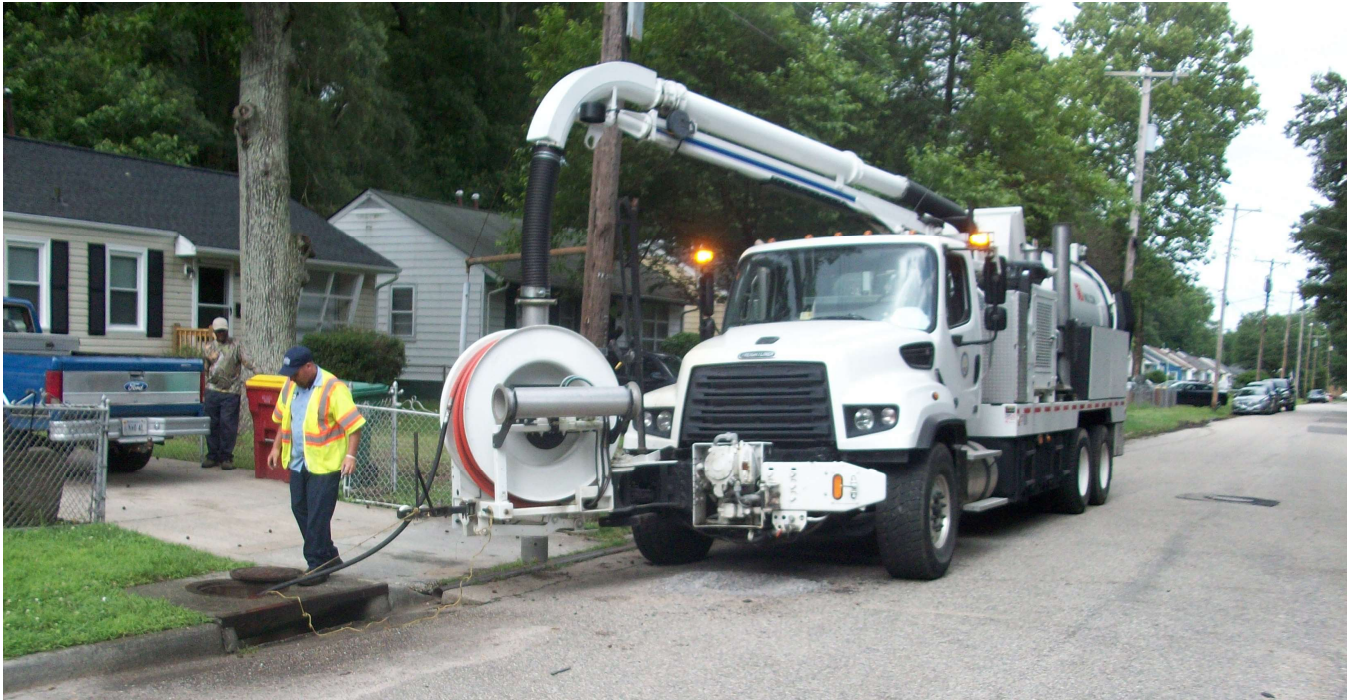
with further understanding of existing systems and gather additional data. A substantial amount of sedimentation throughout the project site was observed.

**Figure 8. Storm drain cleanout by City Street Operations staff, June 12, 2018.**

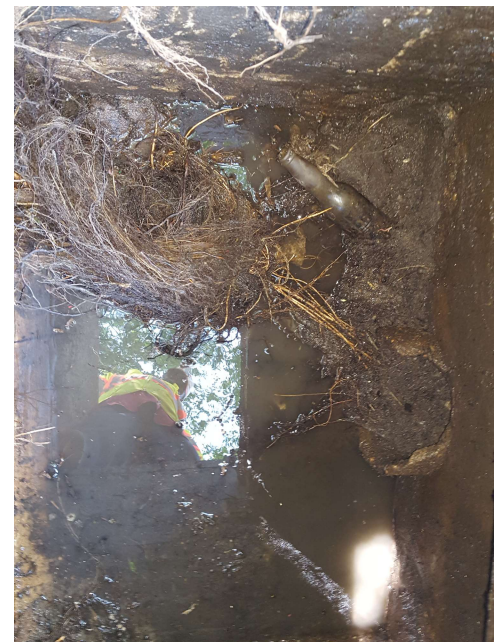
Slagle Avenue at Hare Street: Storm inlets at this intersection connect to the downstream structure located at the intersection of Culpeper and twenty-foot alley. Upon visual inspection, no outlet pipe was located; however, it may be below a significant accumulation of hardened sediment. City Street Operations

**Figure 9. Even after cleaning the inlet, trash, root masses, and sediment clogging the storm drain system remain. The City's infrastructure is old, inadequate, and ineffective.**

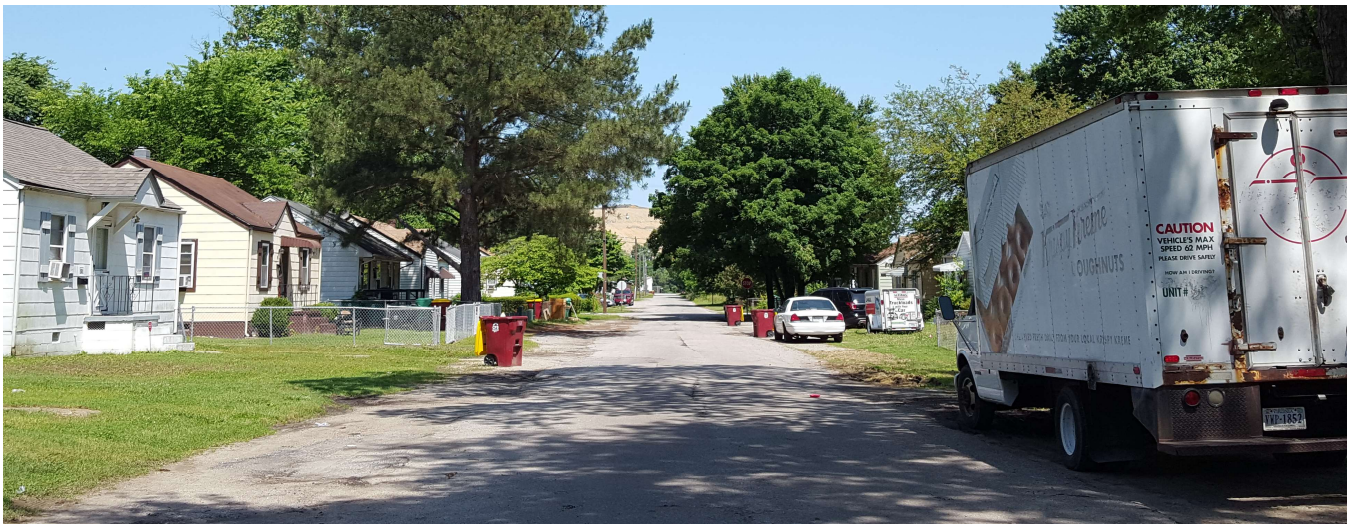
Figure 11. Typical street with view of the landfill. This street has no drainage infrastructure.

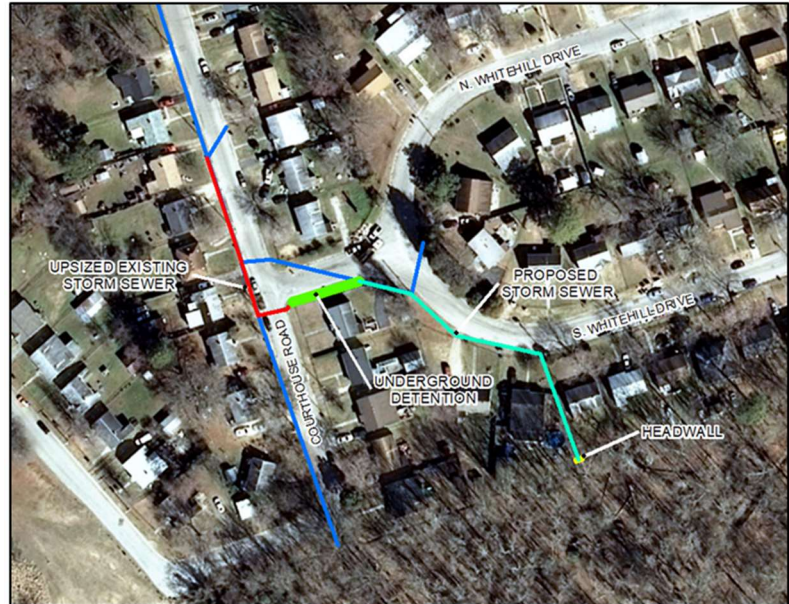
As observed during site investigations, a significant amount of stormwater runoff from the Petersburg National Battlefield is channelized and routes via a natural channel directly toward the rear of residential lots along S. Whitehill Drive before taking a sharp 90° left turn at the property line. At the property line, the channel loses definition, but makes its way along the rear of the lots, ultimately discharging to an existing 15" diameter storm sewer that runs north along Henrico Street. During storm events, a portion of the runoff does not effectively accomplish the 90° bend and proceeds to inundate the backyards of residents. Several options were considered to alleviate flooding of the lots along S. Whitehill Drive, including re-routing upstream drainage, natural channel design through the wetland, a vegetated berm to protect the properties, etc.; however, ultimately any improvements through the Petersburg National Battlefield would result in significant wetland impacts, potential cultural resources implications, and federal requirements would need to be satisfied. The proposed storm sewer re-alignment would convey drainage past the inundated properties in an enclosed system, result in minimal wetland impacts, and address flooding along Henrico Street by controlling peak discharge in a potential underground detention system prior to outlet to the existing system. Once the storm event subsides and the incoming runoff ceases, the water stored in the underground detention chamber would either slowly discharge and navigate through a series of upsized pipes into the existing storm sewer system, or slowly infiltrate into the ground.

Figure 13. Proposed Improvements.

The Battlefield Flood Remediation and Drainage Improvements project is anticipated to cost approximately \$350,000, based on initial estimates prepared and presented in Appendix H. The project, as presented, does not include explicit stormwater water quality treatment mechanisms as it is proposed to address localized flooding issues via a combination of improved stormwater conveyance and underground detention. The exact quantity of stormwater that would be routed through the system and stored in the underground detention chamber(s) requires comprehensive modeling and design to accurately determine.

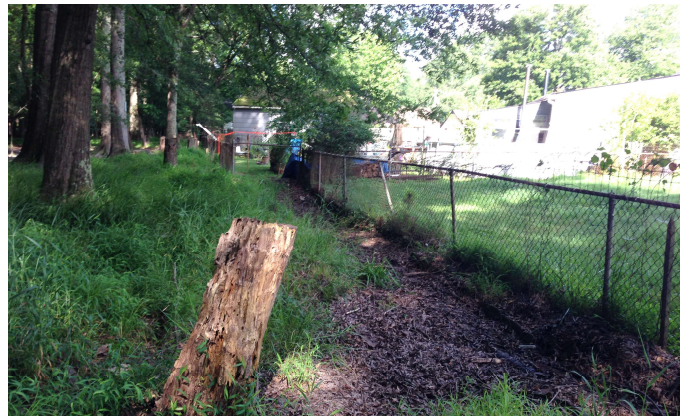
**Figure 14. Drainage channel from Petersburg National Battlefield looking downstream approaching S. Whitehill Drive (above) and after taking the 90° turn along the property line (below).**

conveyance system then turned 90° to the west and followed the property line to the headwall and 12"-diameter storm sewer pipe opening on Henrico Street. The team then continued to explore drainage conveyance features in proximity to the Lakemont Elementary School. A summary of the site visit and recommendations are provided in Appendix E.

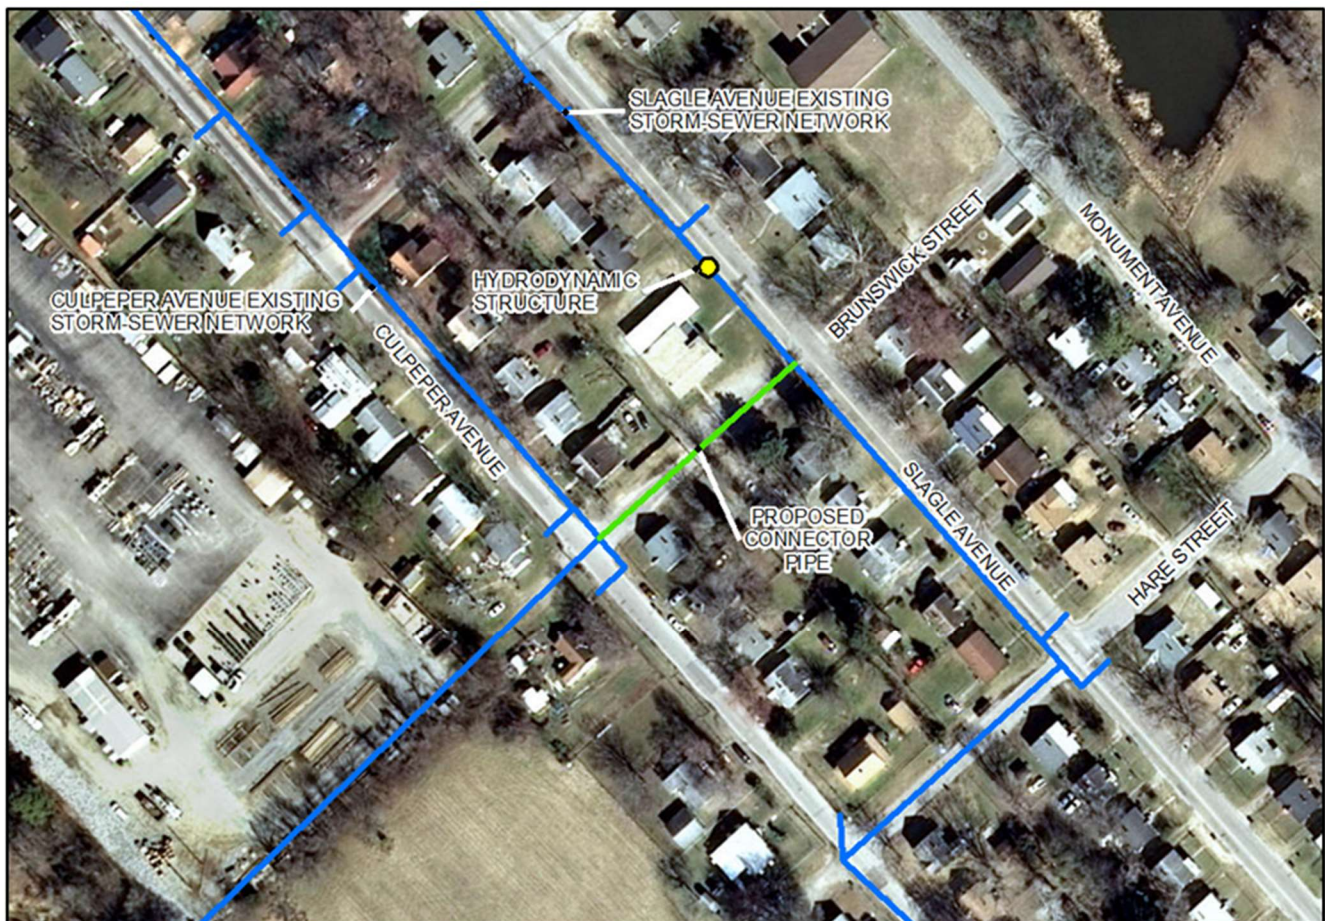
Retrofit hydrodynamic structure along Slagle Avenue between Prince George and Brunswick to provide water quality treatment and enhance maintenance access. Intercept drainage from Slagle Avenue and redirect flow through a new storm sewer segment from Slagle Avenue along Brunswick to the Culpeper Avenue storm sewer system to alleviate localized flooding at Slagle Avenue and Hare Street intersection.

Figure 15. Proposed Improvements.

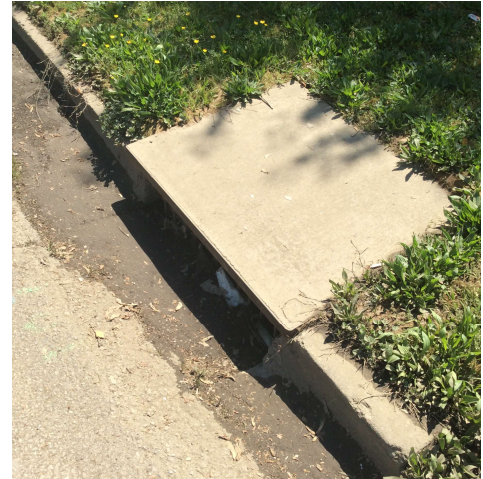
Figure 16. Sediment in the gutter pan along Slagle Avenue.

Additional observations included: inconsistent slopes in gutter pan along Slagle Ave, Courthouse Street, Henrico Street, and Whitehill Drive. These inconsistencies contribute to low spots, trap water and sediment, and create ponding areas in the gutter pan. A total of 23 stormwater inlets were located, and manhole covers were opened to observe the condition of structures and confirm pipe sizes and directions. Some structures were full of debris; City employees removed trash and sediment from structures as requested for a total of four (4) inlets. The following are detailed observations from the field investigations:

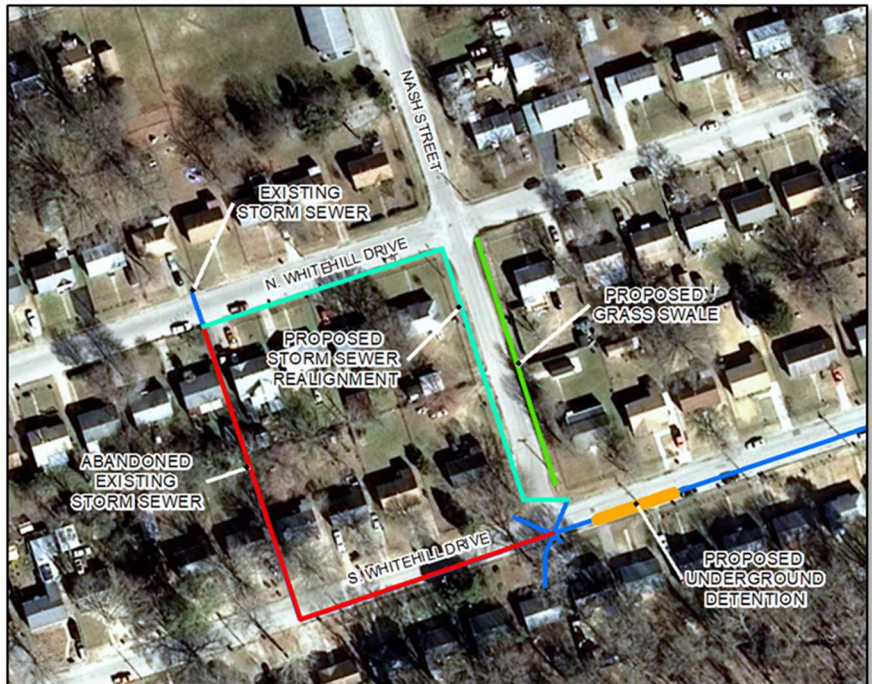
The City of Petersburg maintenance crews commented that there is a blockage or crushed pipe within the existing storm sewer that runs through two properties just south of N. Whitehill Drive that is preventing the conveyance of stormwater and is flooding N. Whitehill Drive.

Figure 17. Proposed Improvements.

Due to the size of the existing system (12"-diameter) and the proximity to adjacent homes, as well as the lack of a drainage easement, it is not feasible to replace or upgrade the pipe system along its existing alignment. If the pipe was intact, cured in place pipe lining might be a viable option; however, the pipe is undersized by present day standards and City staff believe it may have failed due to complete blockage or collapse; therefore, an alternative alignment is proposed. The Whitehill Storm Sewer Drainage Improvement project proposes to alleviate the flooding on N. Whitehill Drive by rerouting the storm sewer system along the alignment illustrated in the Figure above. The existing storm sewer running between properties would be abandoned in place.

The proposed storm sewer would tie into the existing system along the southern side of N. Whitehill Drive and run towards the intersection of N. Whitehill Drive and Nash St. at which point it would take a 90° right angle and run along the side of Nash St. towards S. Whitehill Drive. The appropriate configuration of existing and proposed tie-in to the storm sewer system along S. Whitehill and the necessity of any underground detention to control peak flow discharges to the existing system would need to be determined based upon hydraulic analyses and modeling during design. Designers should consider a grass channel swale along Nash, perhaps on both sides to enhance the water quality treatment potential of the system.

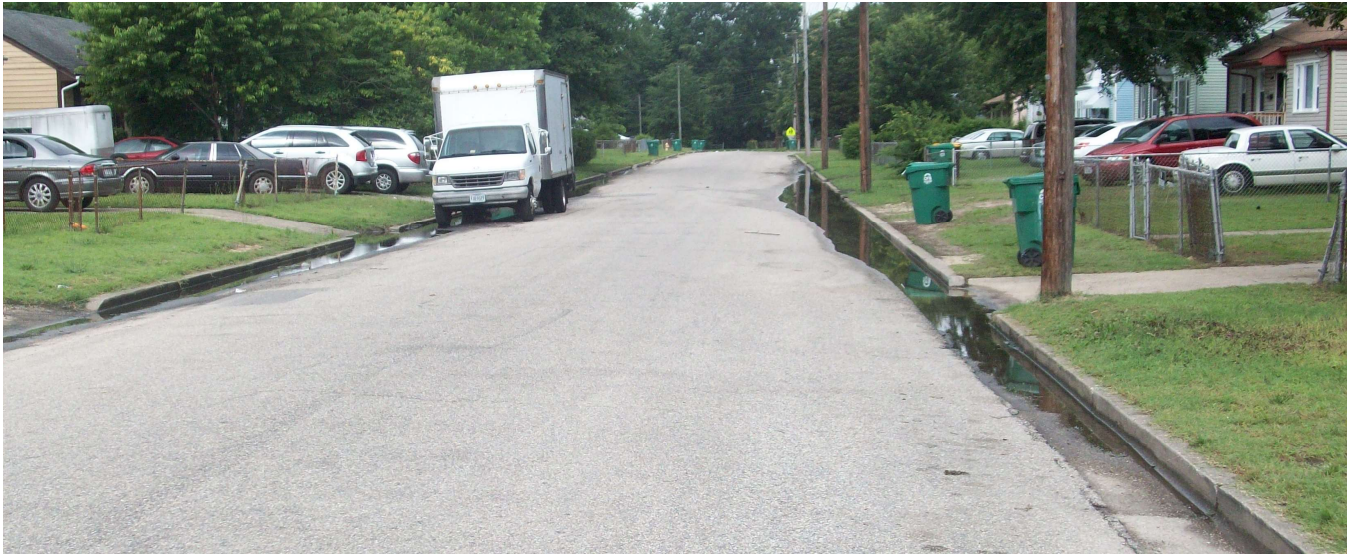
Figure 18. Stormwater extends from inlet to inlet across N. Whitehill Drive during precipitation events due to lack of adequate drainage infrastructure.

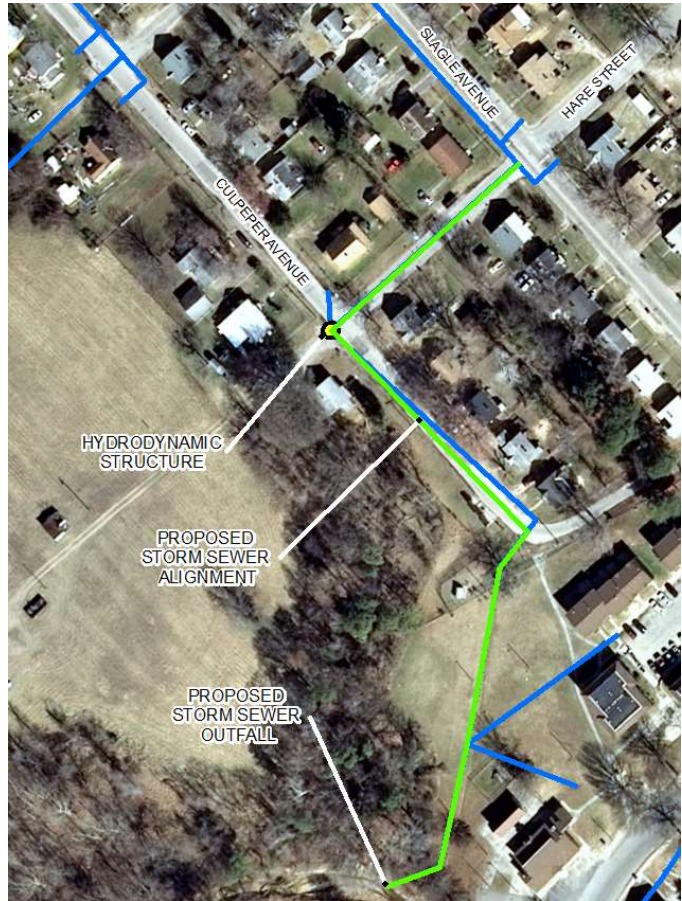
The intersection of Slagle Avenue and Hare Street frequently experiences flooding, standing water, and sediment laden gutter pans because of poor drainage conditions and a storm-sewer system that has a high sediment accumulation rate. Further, during site investigations with City staff, it was remarked that when they vacuumed the inlet near the intersection of Culpeper and the Alley, the flooding at the intersection of Slagle and Hare is alleviated. Several possible scenarios could be the cause of this phenomenon, including: inverted pipes, sub-standard pipe sizes, inefficient hydraulic capacity, sediment accumulation, blockages downstream, etc.; however, based on the age of the infrastructure and the complexity of the existing network, a drainage improvement upgrade for the storm sewer system from the Slagle and Hare intersection to the outfall is proposed. Further, the project should include at

Figure 19. Proposed Improvements.

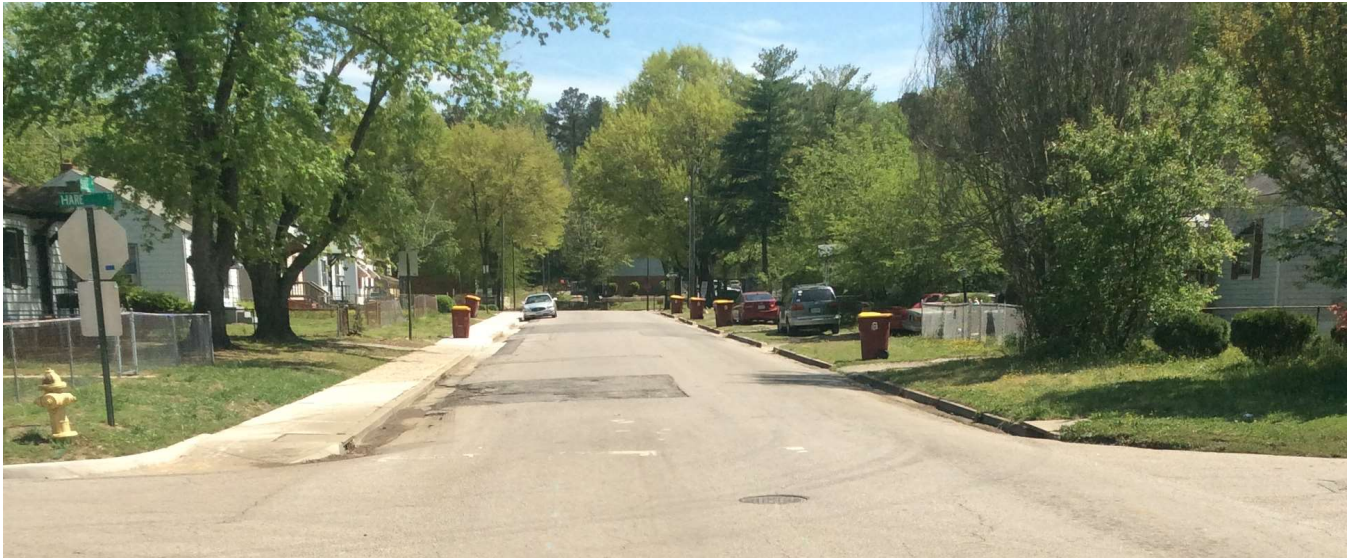
Figure 20. Slagle and Hare intersection looking south along Slagle Avenue.

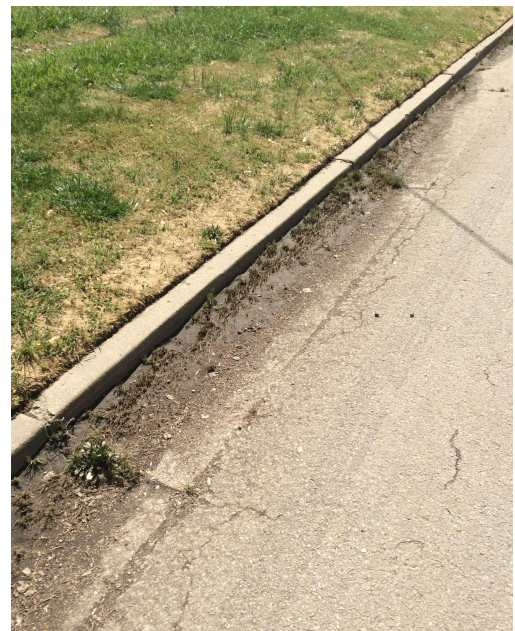
Figure 21. Sediment laden gutter pans along Slagle Avenue.

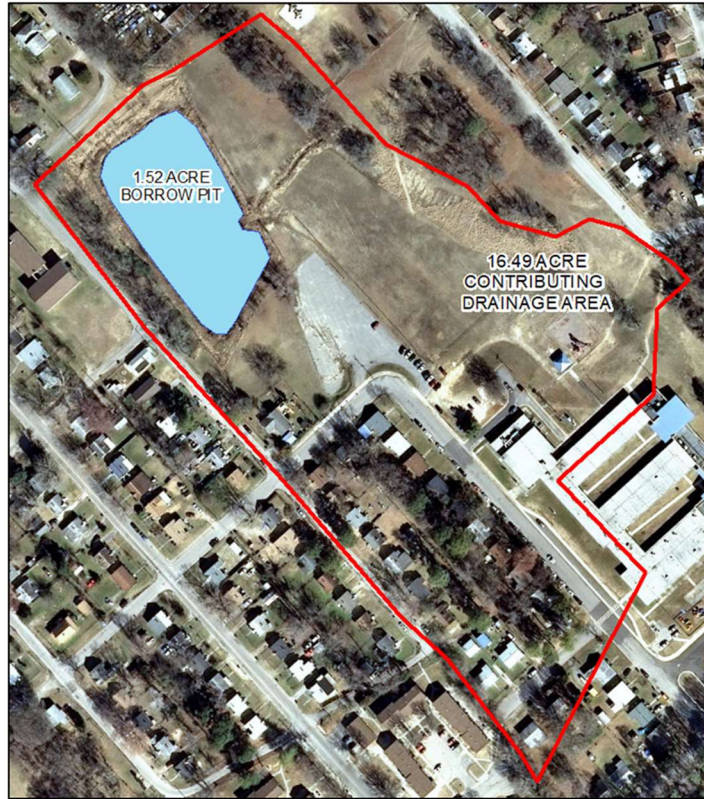
Located on the Northwest portion of the Elementary School property is an abandoned borrow pit with a normal pool area of approximately 1.52 acres. The borrow pit has no known outlet structure, resulting in the complete, 100% capture and treatment of the runoff it receives from its 16.49 acre contributing drainage area. The location of the existing borrow pit and contributing drainage area are illustrated in the Figure to the right.

**Figure 22. Existing borrow pit contributing drainage area (CDA). The borrow pit is presently 100% effective at water quality treatment of the 16.5-acre CDA.**

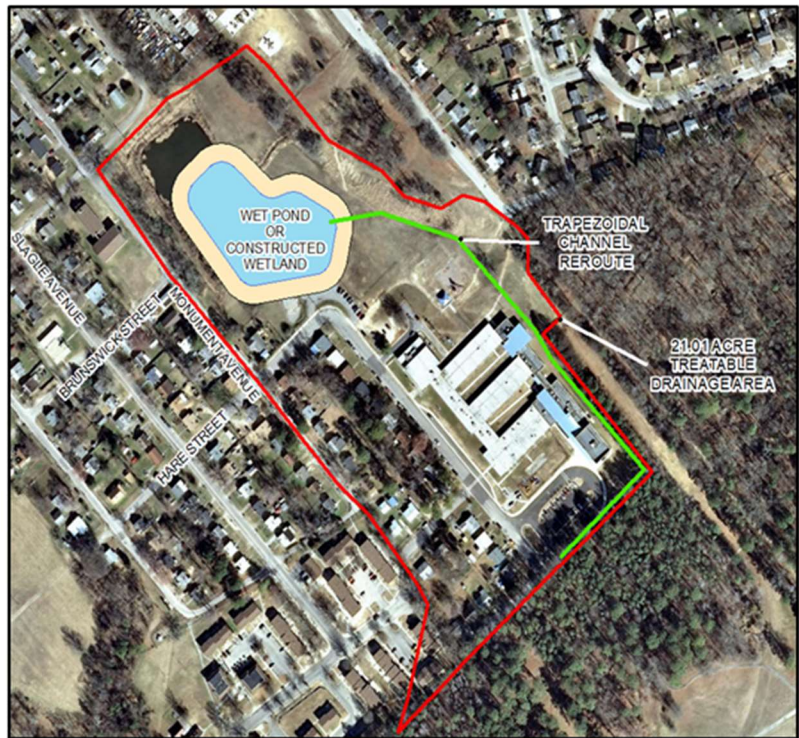
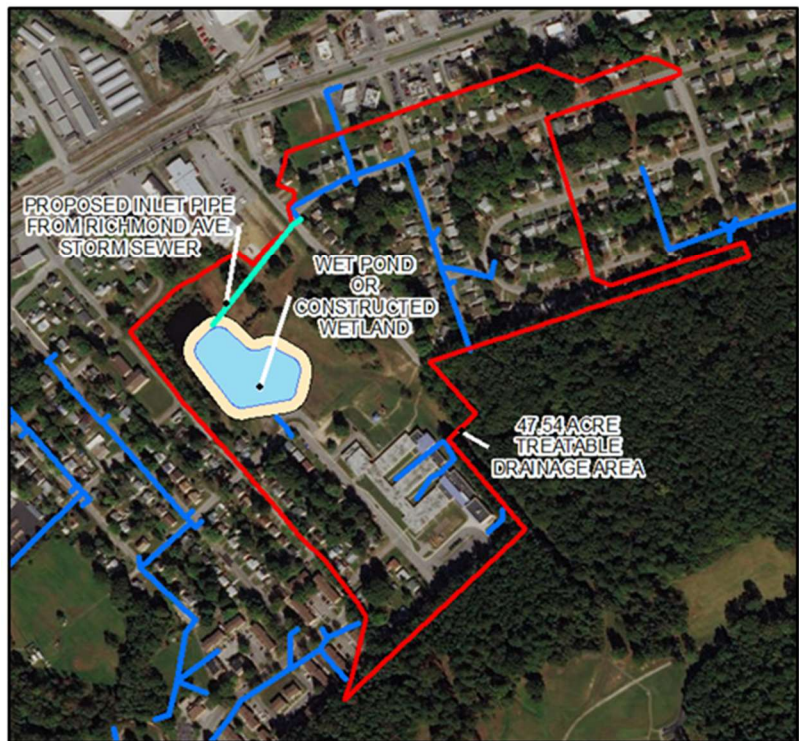
Although preliminary hydrologic and hydraulic calculations show that the proposed Pond can contain the 24 hour 100-year storm event without overtopping, even without an outlet structure, an emergency spillway will need to be installed to prevent any potential flooding from a more severe storm event. The proposed emergency spillway would consist of a riser structure and outfall pipe that would tie-in to the existing storm sewer on Slagle Avenue before eventually discharging into Poor Creek; however, ideally the Culpeper Storm Sewer Extension project would proceed the Lakemont Water Quality Retrofit project, so that the Culpeper drainage system could be used to route overflow discharges to Poor Creek.

Figure 23. Options 1 (above) and 2 (below) to re-route drainage to the borrow pit.

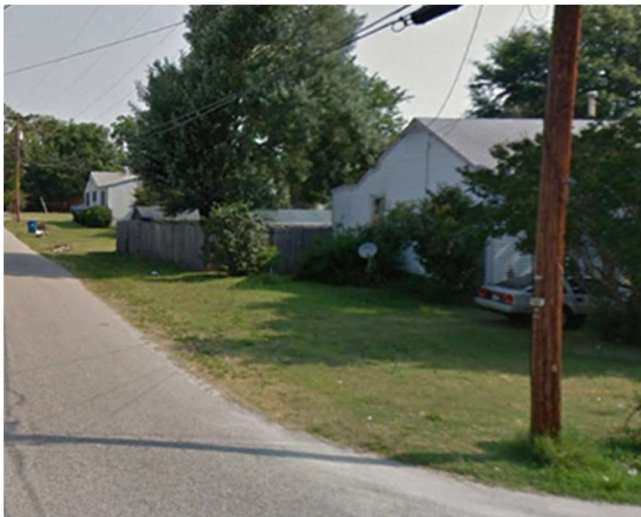
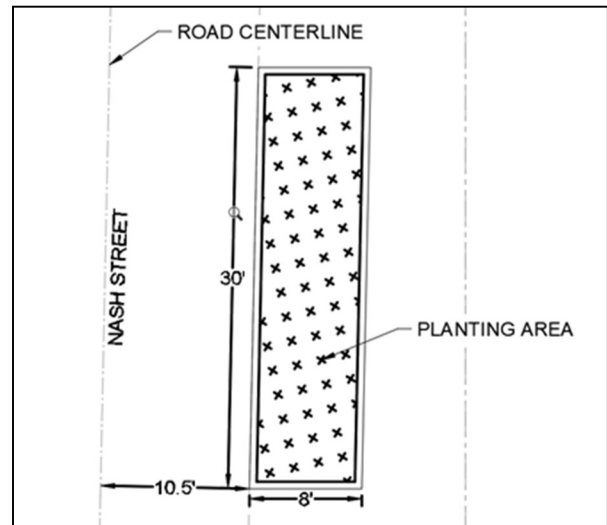
Move the ponding underground within the right-of-way along Nash Street, near the intersection with N Whitehill Drive by designing a bioretention rain garden to collect and treat stormwater runoff.

Figure 24. Proposed bioretention rain garden street view (left) and conceptual layout (right).

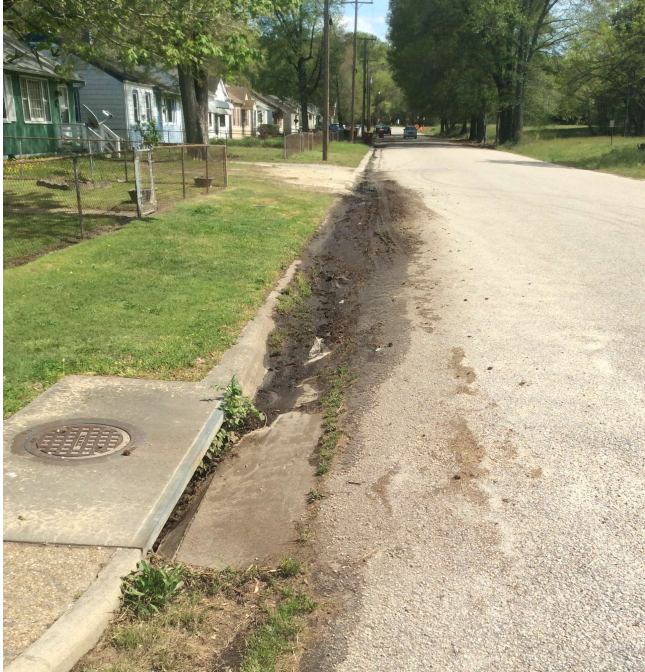
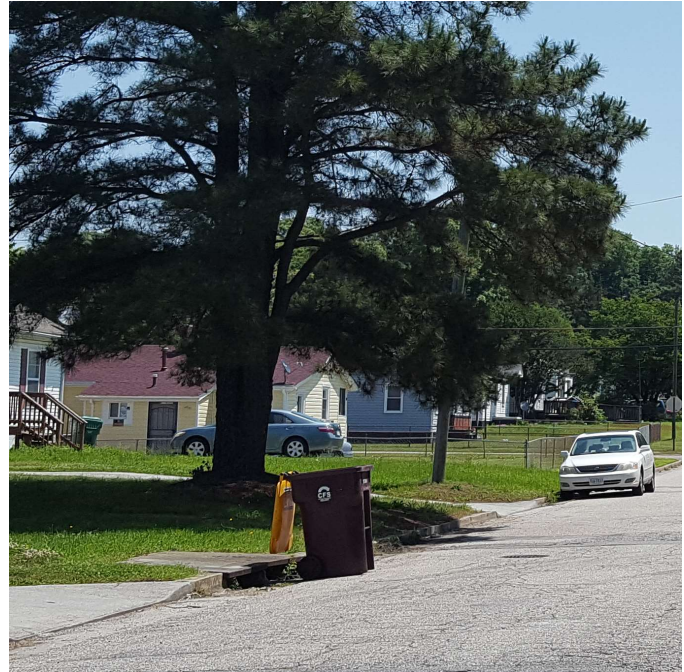
Create on-street bioretention areas using curb bump outs to collect and treat stormwater while achieving neighborhood beautification and traffic calming. Sites along Courthouse Road and Richmond Avenue have been identified as the best candidates for demonstration scale installation.

Figure 25. Proposed locations for bioretention bump-outs along Courthouse Road (left) and Richmond Road (right).

The pilot locations for implementation of bioretention bump-outs were selected based on their apparent lack of site constraints; however, a significant sediment load was noted along the gutter pan on Courthouse. In fact, the inlet to which the bioretention bump-out would tie was cleaned during the May site visit with City staff. If the sediment load is not addressed prior to installation, the bioretention bump-out will likely be inundated with a sediment load subsequently stifling the vegetation and clogging the bioretention media. It is recommended that an education campaign and maintenance plan be established prior to implementation to reduce failure of the stormwater control measure due to sedimentation.

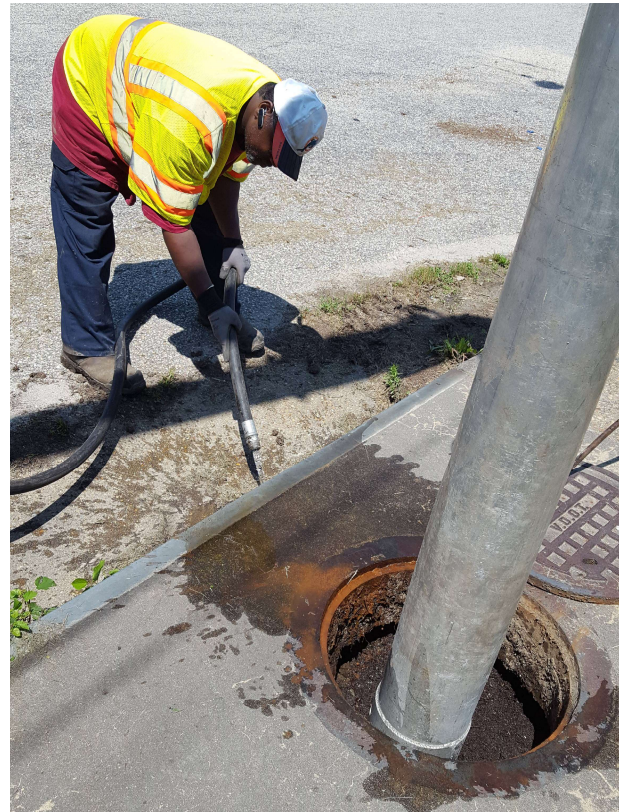
Figure 26. Jetting and vacuuming the inlet filled with sediment at the intersection of Courthouse Road and Richmond Road.

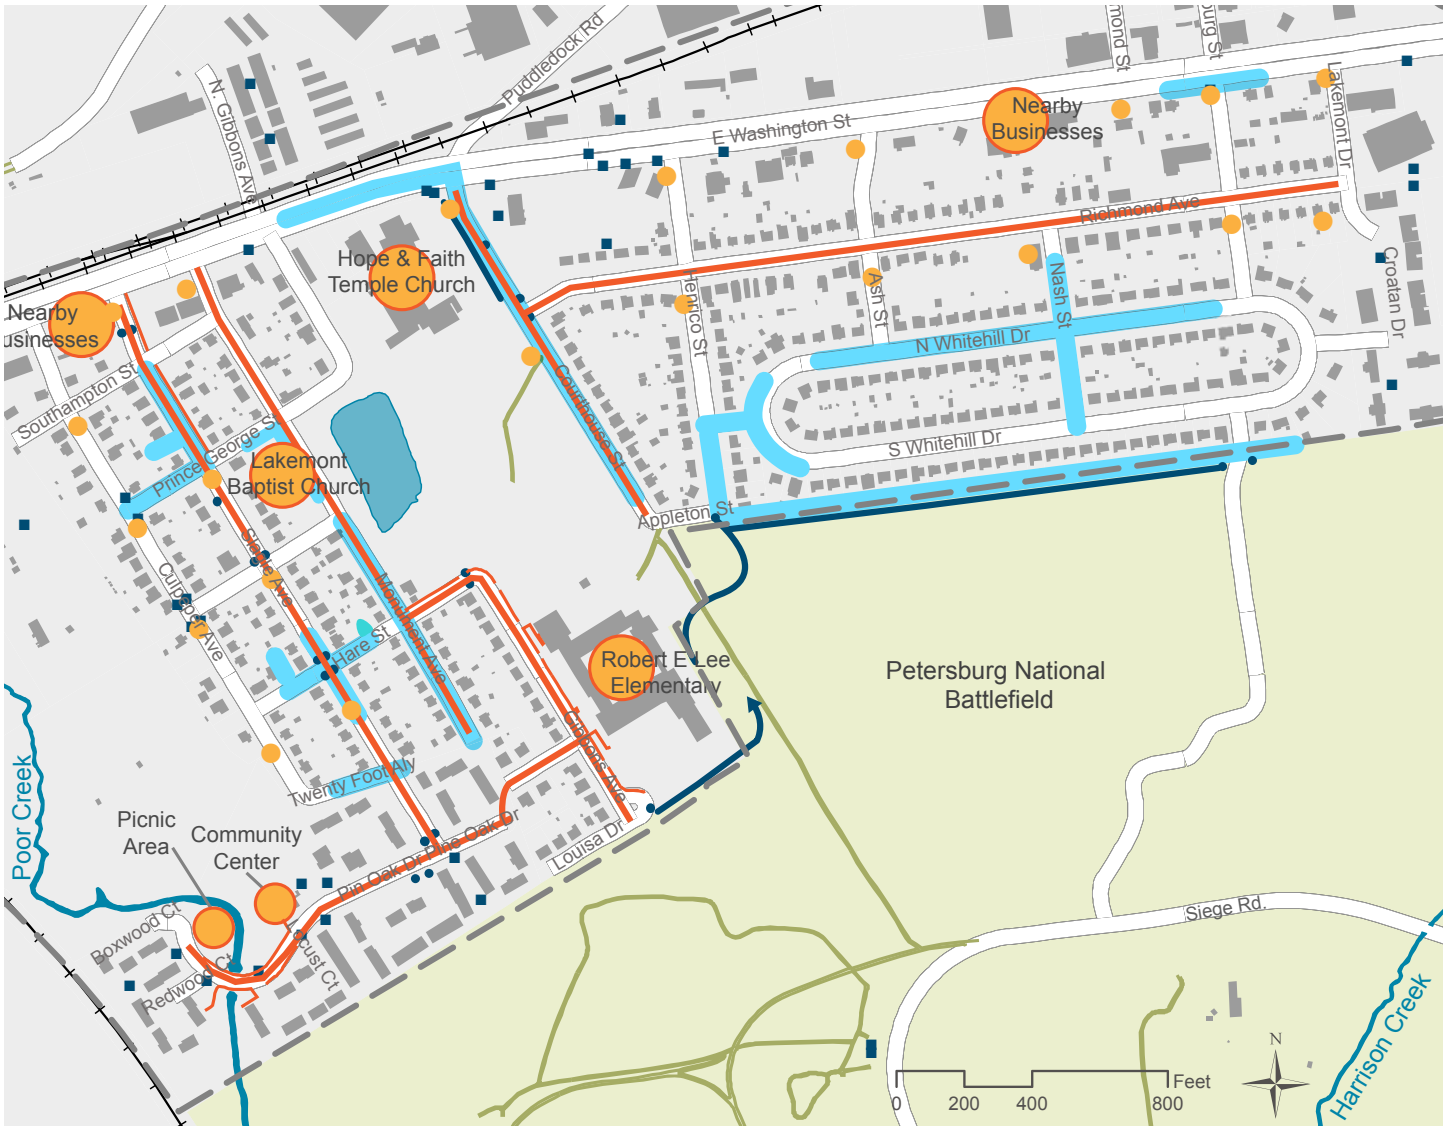
## Existing Conditions

- Community Destinations
- Transit Stops
- Primary Routes
- Existing Sidewalks
- Storm Inlet
- Catch Basin
- Ditch or Concrete Channel
- Resident Reported Flooding

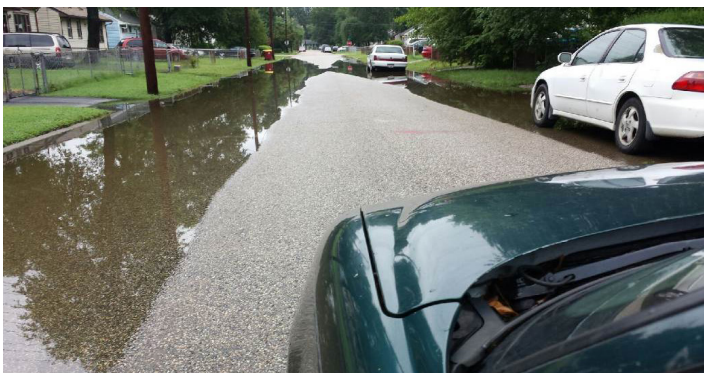
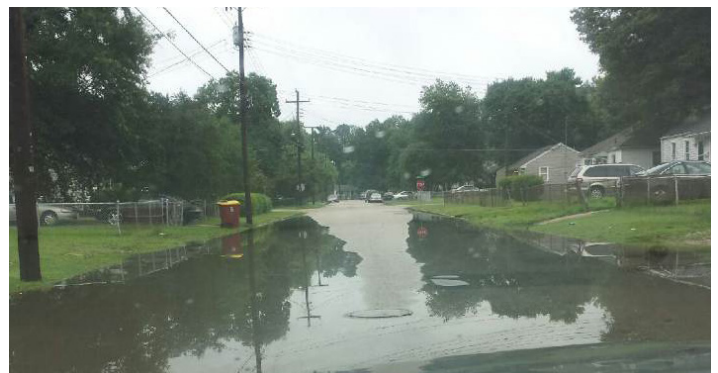
Photos taken by residents document the flooding that occurs during rain events. In the event of heavier rainfall, roads in the neighborhood can be hazardous to drive on due to the depth of stormwater flooding the streets. Especially when stormwater floods impervious areas, it can collect litter, debris and hazardous materials such as oil from roads. These hazardous materials, will eventually drain into storm inlets and ultimately reach the Chesapeake Bay and contribute to water pollution.

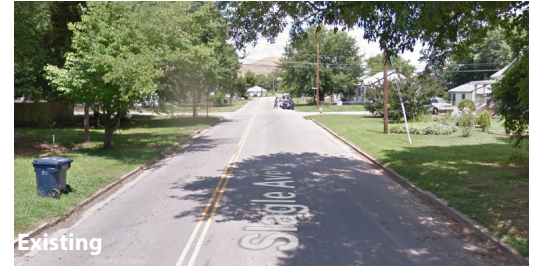
Example of how curb extensions, street parking, and vegetation between sidewalk and street could be added along Slagle Avenue.

- A Slagle Avenue** - Add sidewalk to connect with new sidewalk. Narrow traffic lanes to help slow traffic. Integrate natural drainage strip between sidewalk and streets to absorb stormwater. Include on-street parking on one or both sides of street.
- B Courthouse Avenue** - Widen swale on east side of road. Clean and maintain storm drains. Consider upgrading drainage pipe at Courthouse and Appleton.

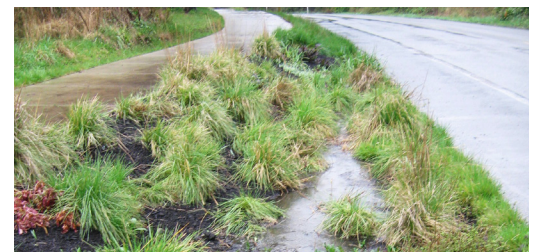
Example of a planted swale during rain event

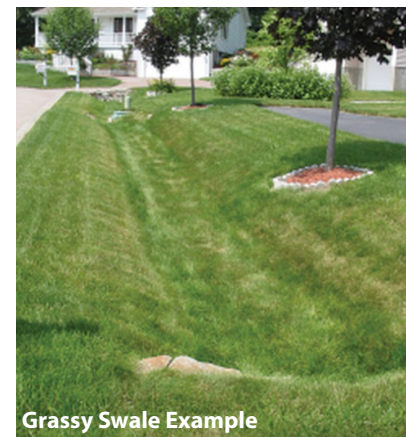
**Grassy Swale Example**

Grassy swales along streets without sidewalks could address street flooding by providing holding space for stormwater during rain events -- swales are designed to drain after rain event to avoid standing water. Swales can also be designed for ease of maintenance and to minimize trash collection.

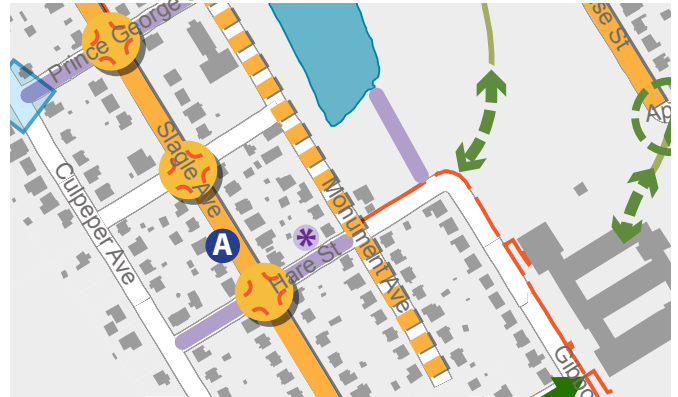
Example of a vegetated traffic circle in a residential neighborhood that slows traffic, collects stormwater and adds aesthetic value. A drainage study will identify whether there is adequate road width and right of way to accommodate a traffic circle.

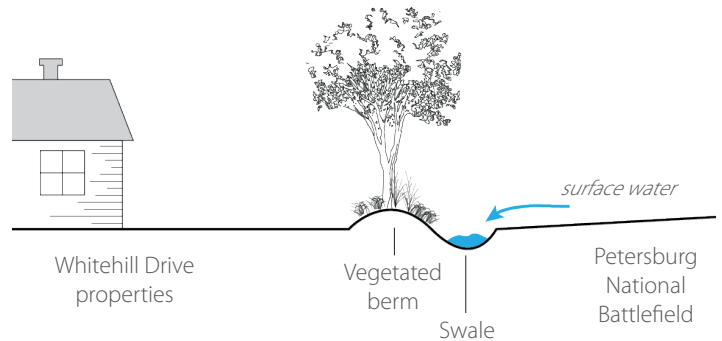
A planted buffer along an expanded swale will allow surface water draining from the Petersburg National Battlefield to be collected without flooding residential properties and maintain a visual buffer between residential neighborhood and the park.

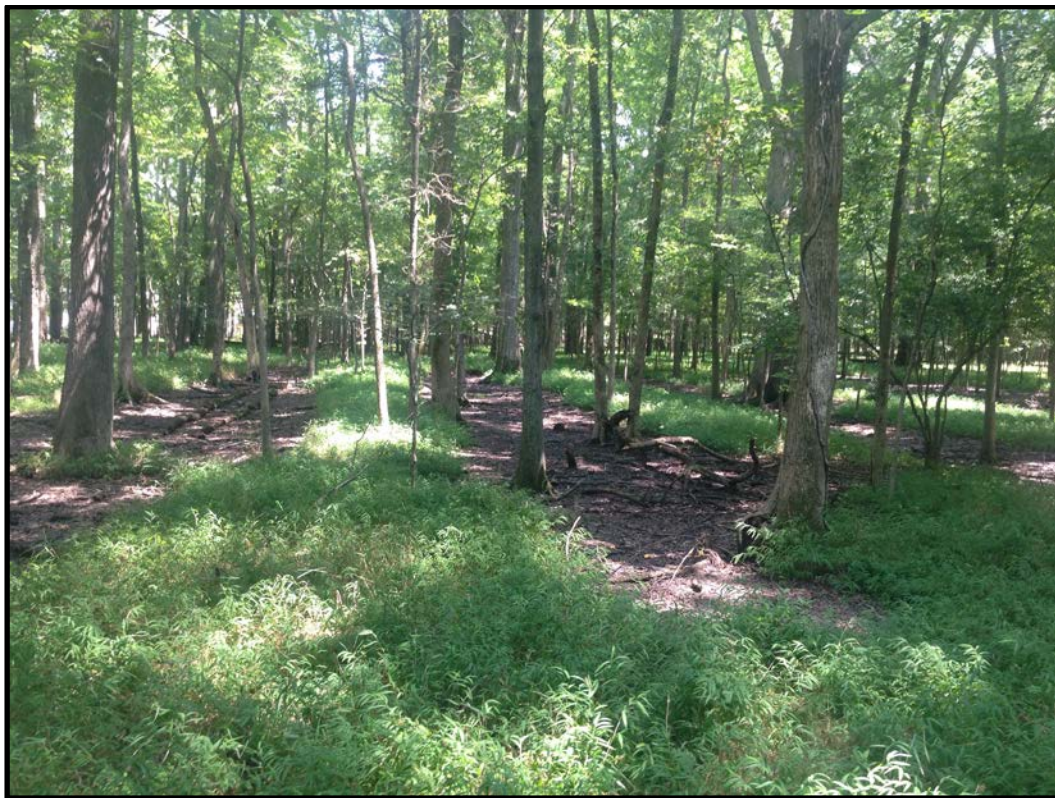
Photograph 1 (P1). Photo looking Northeast at Wetland 1 and a few of the CCC era drainage features which bisect the habitat within the study area boundary at PETE. August 2018

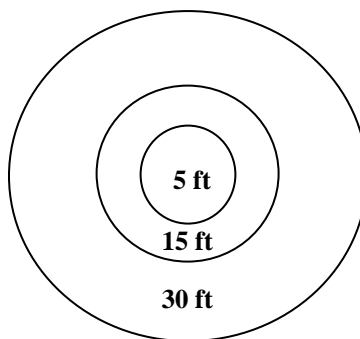
Figure 2. Typical wetland vegetation survey plot utilized within the study area.

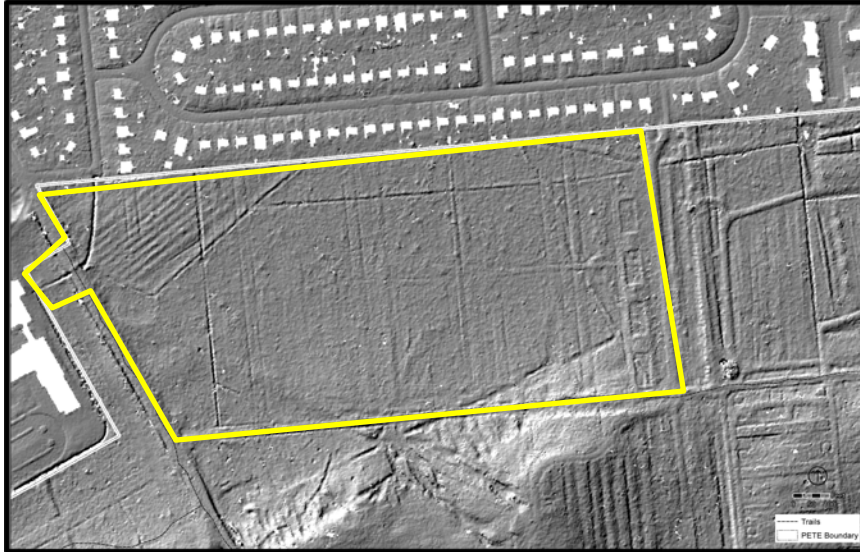
Figure 3. LiDAR image of the study area provided by PETE staff (Adam Baghetti). From the imagery the network of drainage ditches bisecting the Study Area (yellow boundary) can be easily seen.

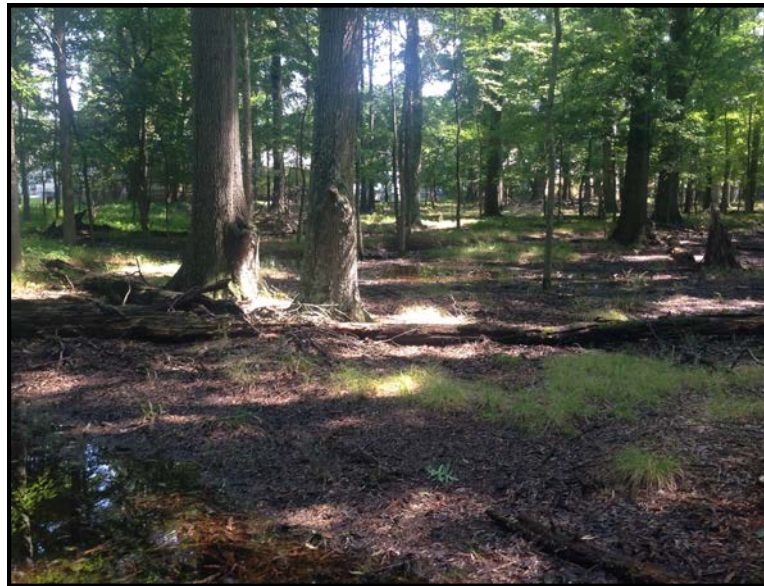
Photograph 2 (P2) – Wetland 1 (PSS1E) view facing north. Photo September 2017 – P. Sharpe.

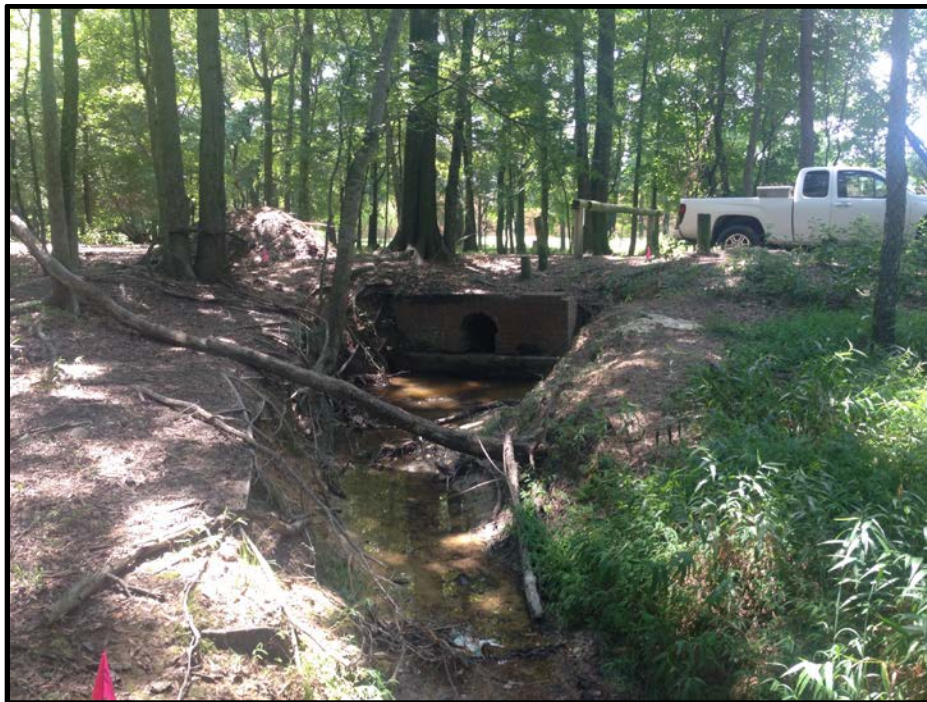
Photograph 3 (P3) – Mapped riverine wetland system shown on NPS lands view is southeast looking upstream at the system and its riparian zones September 2017 – P. Sharpe.

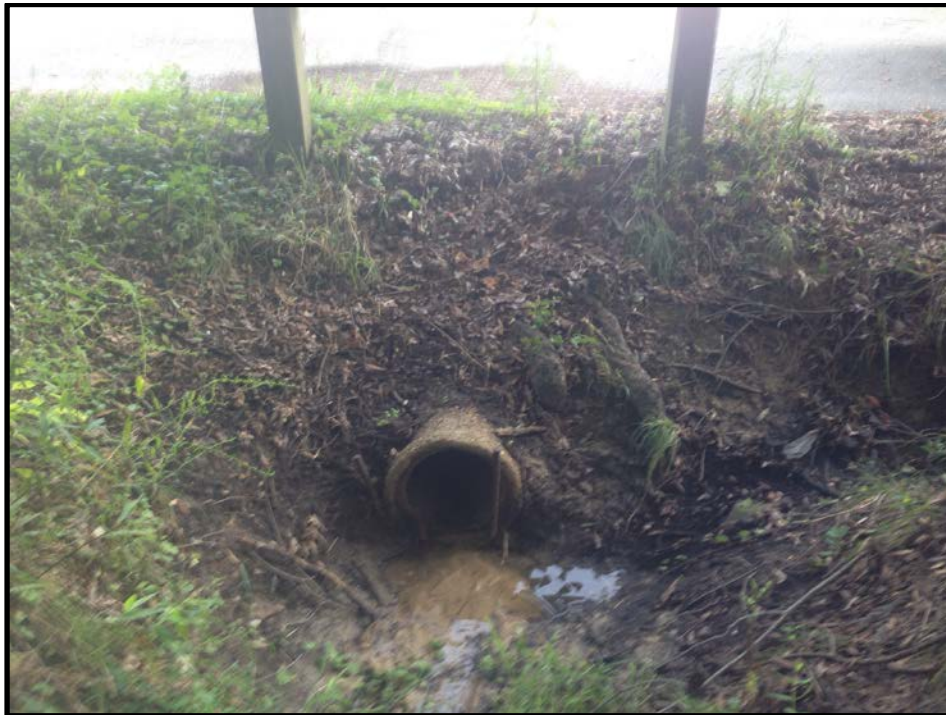
Photograph 4 (P4) – 12 inch RCP which serves as the only visible outlet for the 85.52 acre watershed system draining to this point. View is northwest August 2017 – P. Sharpe.

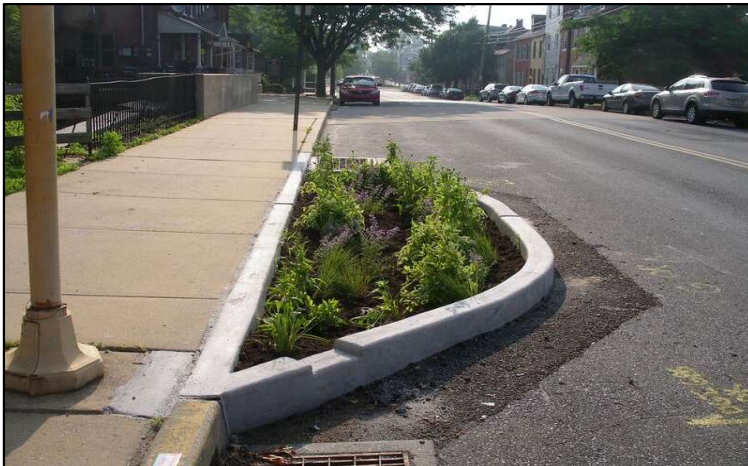
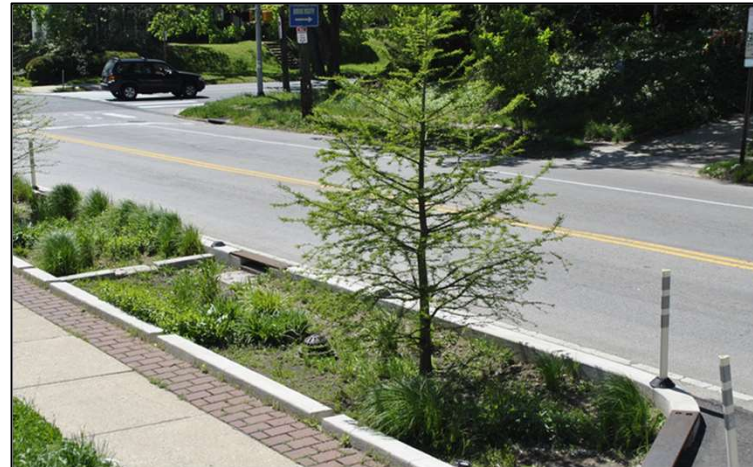
**Figure 1.** Example Bioretention Bump-out features
