# Lakemont Neighborhood Drainage Study

National Fish and Wildlife Foundation  
Chesapeake Bay Stewardship Fund,  
Grant #58834

March 1, 2019

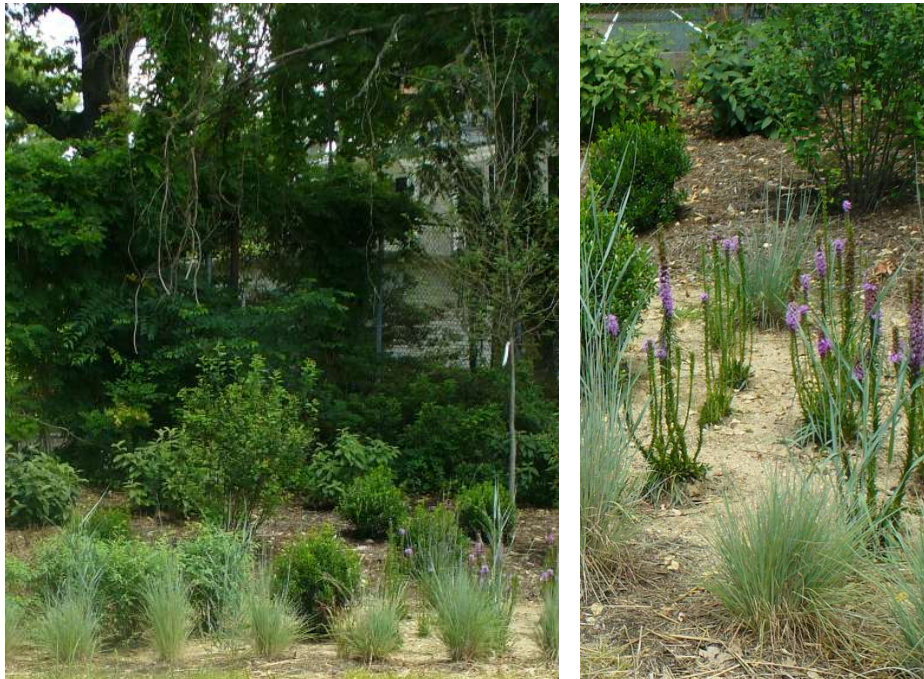
**Figure 2.** Handy Lane Rain Garden, Richmond, VA

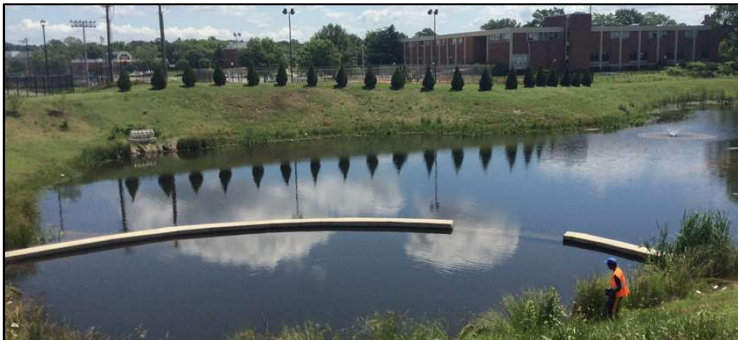
**Figure 4.** Trojan Stormwater Management Pond, VSU

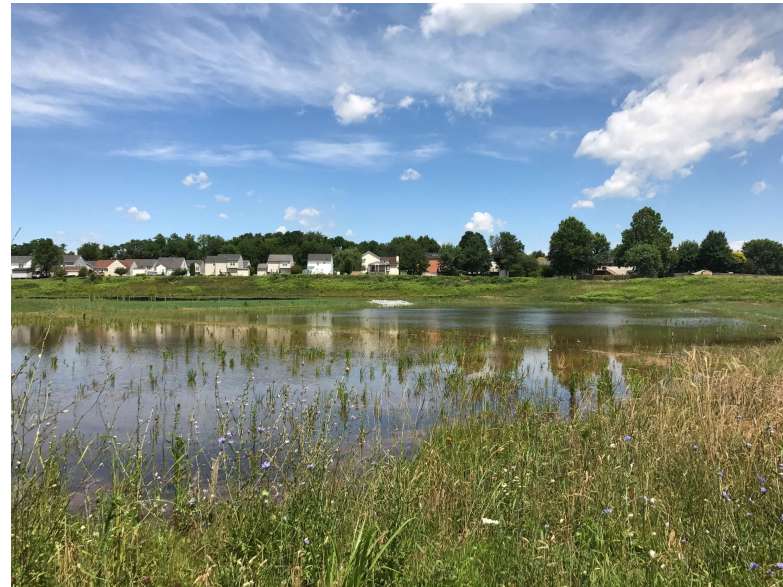
**Figure 5.** Mulberry Run Constructed Wetland, Waynesboro VA

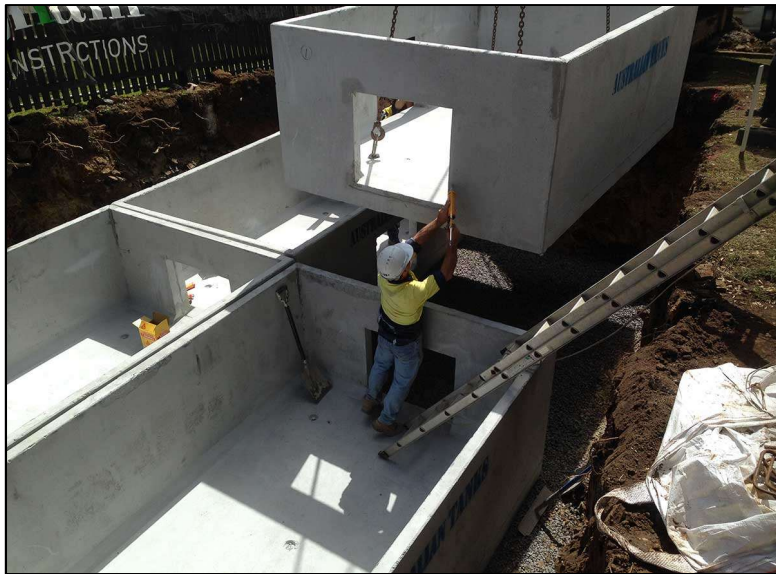
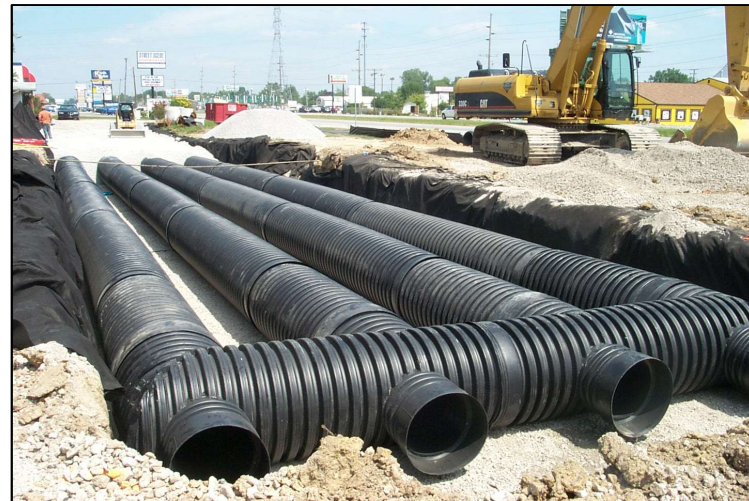
**Figure 5.** Example Underground Detention Chambers

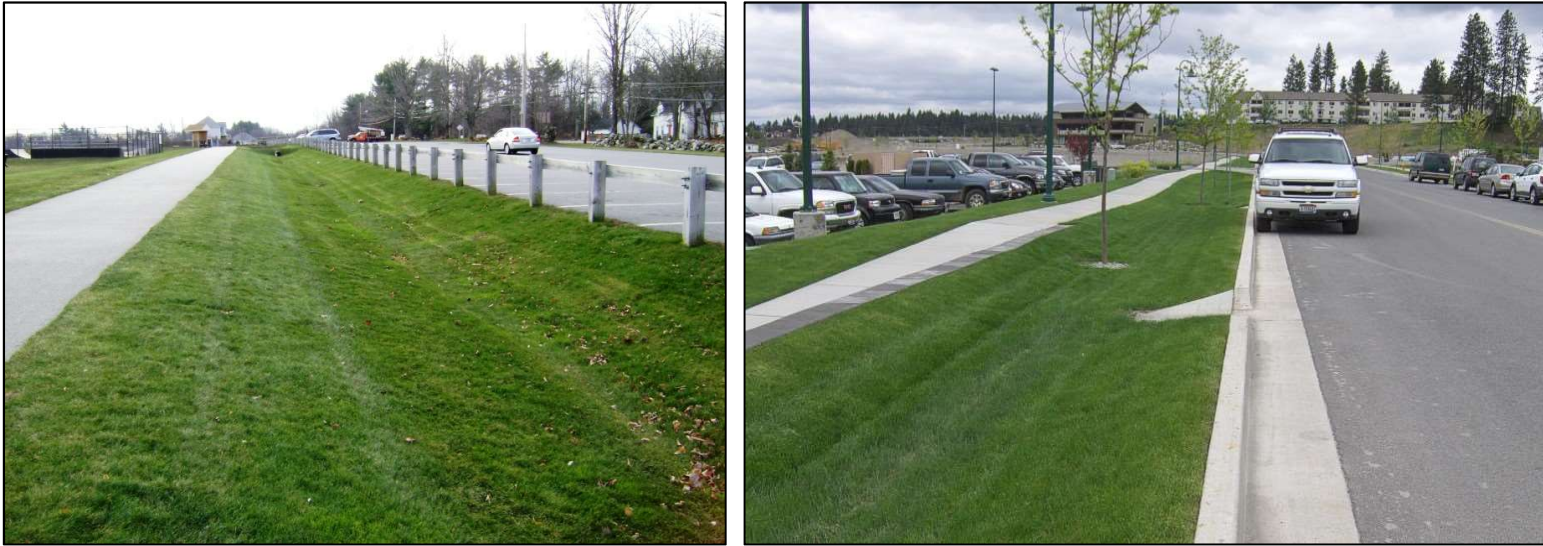
**Figure 6.** Example Grass Swales

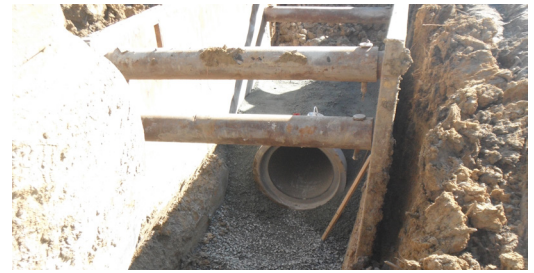
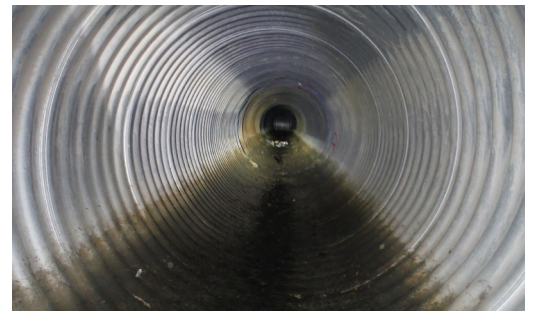
Examples of storm sewer infrastructure installation (top) and an underground detention (above).

**G Battlefield Flood Remediation and Drainage Improvements** - Install new storm sewer system to collect uncontrolled drainage from the National Battlefield and route to existing system along Henrico Street. This system would use a headwall and open pipe to collect runoff from the Battlefield that is presently channelized in a ditch system that takes a 90-degree bend at the rear of residences along S Whitehill and loses definition before ultimate discharge to an undersized storm sewer system along Henrico Street.

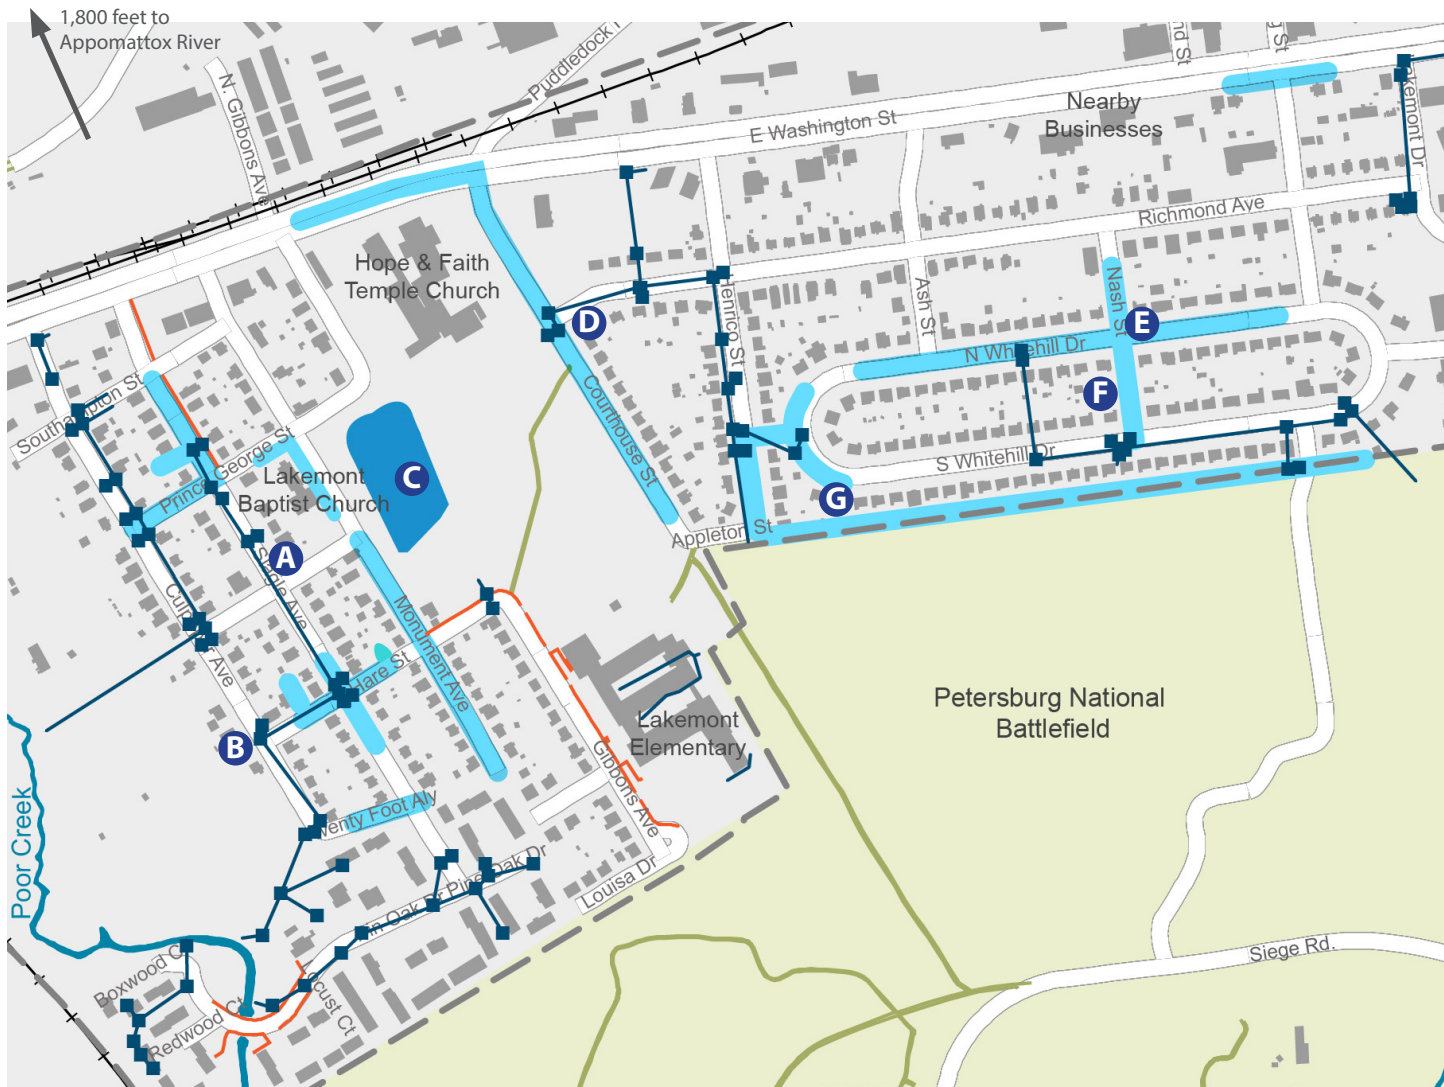
- █ Resident Reported Flooding
- █ Storm Pipe
- █ Existing Sidewalks
- Storm Structure
- A Recommended Stormwater Projects

**F N Whitehill Drive Drainage Improvements** – Alleviate localized flooding along N. Whitehill by establishing a new alignment and hydraulically appropriately sized storm sewer, connecting to S. Whitehill via Nash Street. A grassed swale along the eastern lane of Nash Street and underground detention are proposed to address water quality and quantity requirements.

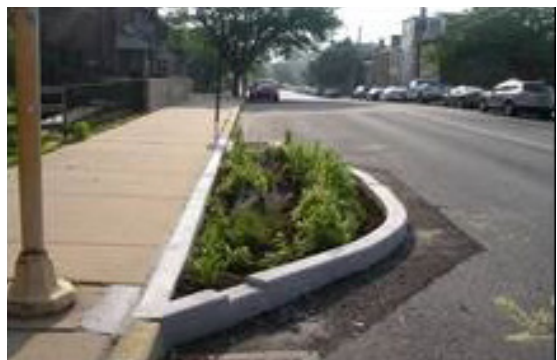
Examples of bioretention bump-outs.
